Property Screening Report

6595 Martinique Way, Vero Beach, FL 32967

FL01-0188

RE: Chinese Drywall Screening Report Number FL07-0252
Property located at: 6595 Martinique Way, Vero Beach, FL 32967

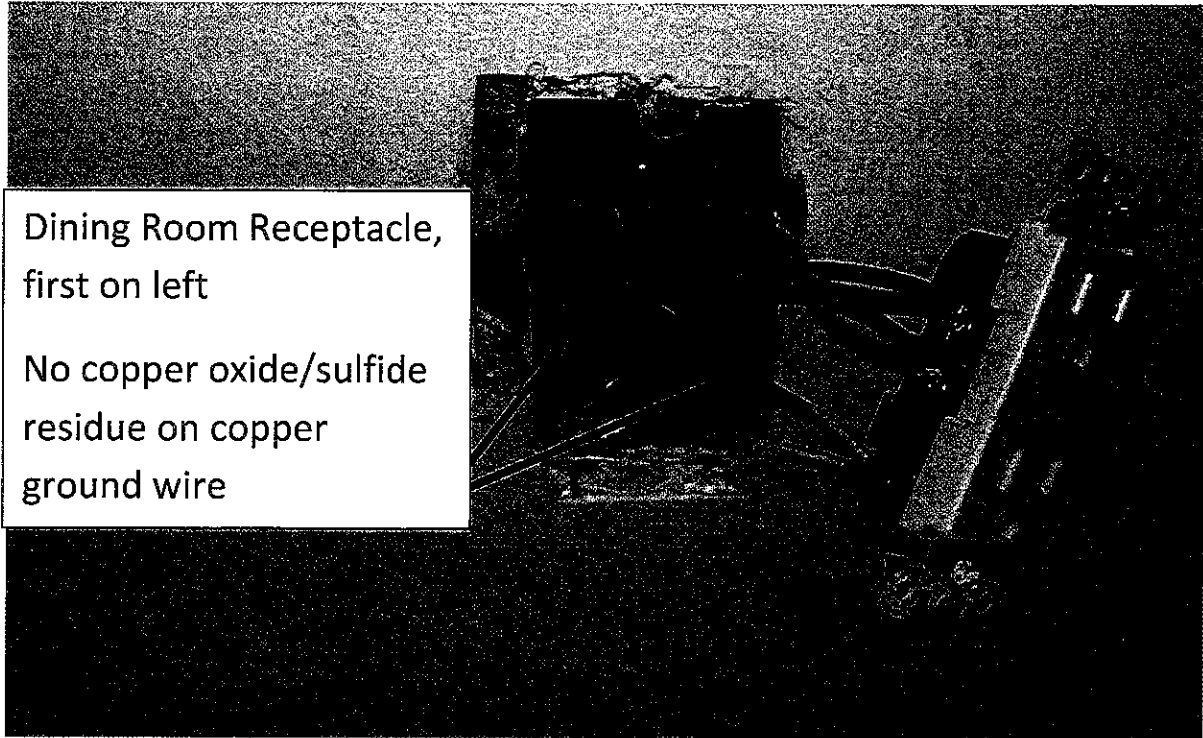
Dining Room Receptacle,
first on left

No copper oxide/sulfide
residue on copper
ground wire
